SUSQUEHANNA RIVER BASIN
KETTLE CREEK, BLAIR COUNTY
PENNSYLVANIA

POTTSGROVE DAM
NDI I.D. No. PA - 00527
PENNDER I.D. No. 7 - 19

PHASE I INSPECTION REPORT
NATIONAL DAM INSPECTION PROGRAM

PREPARED BY
GAI CONSULTANTS, INC.
570 BEATTY ROAD
MONROEVILLE, PENNSYLVANIA 15146

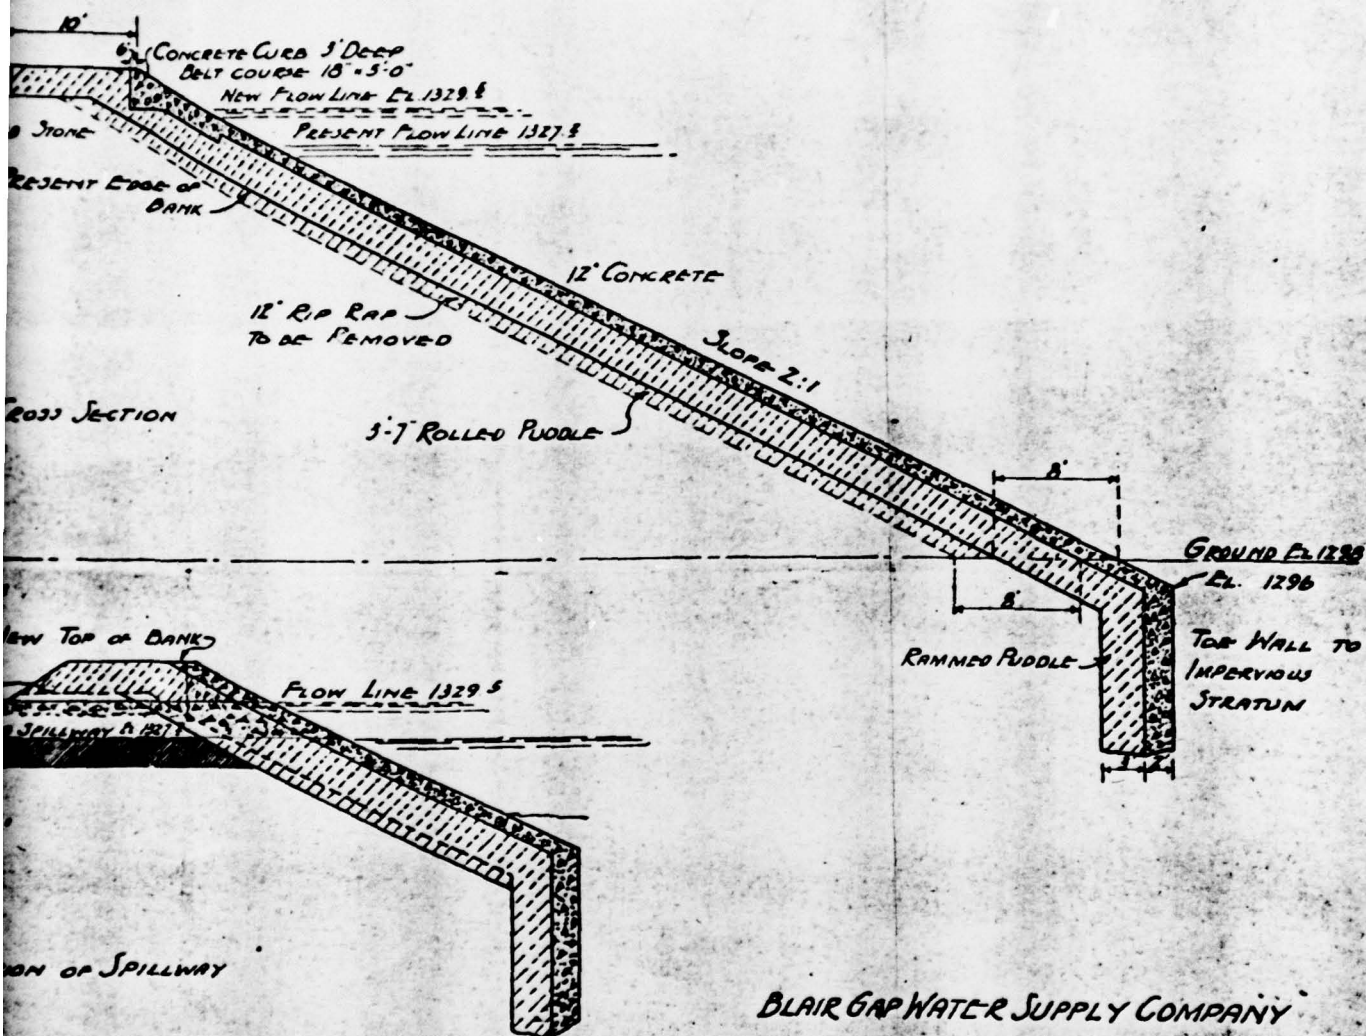
BLAIR GAP WATER SUPPLY COMPANY
POTTSGROVE RESERVOIR
CROSS-SECTION OF RESERVOIR SHOWING
PROPOSED REPAIRS

As a result of a serious seepage problem caused by extensive root decay within the embankment, major modifications were made to the facility in 1918 (see Figure 2). The modifications resulted in the embankment being raised approximately 2 feet, the addition of an impervious upstream facing, the apparent flattening of the downstream slope which was reportedly 1-1/4H:1V, and the construction of a new and larger spillway (see Figures 3 and 4).

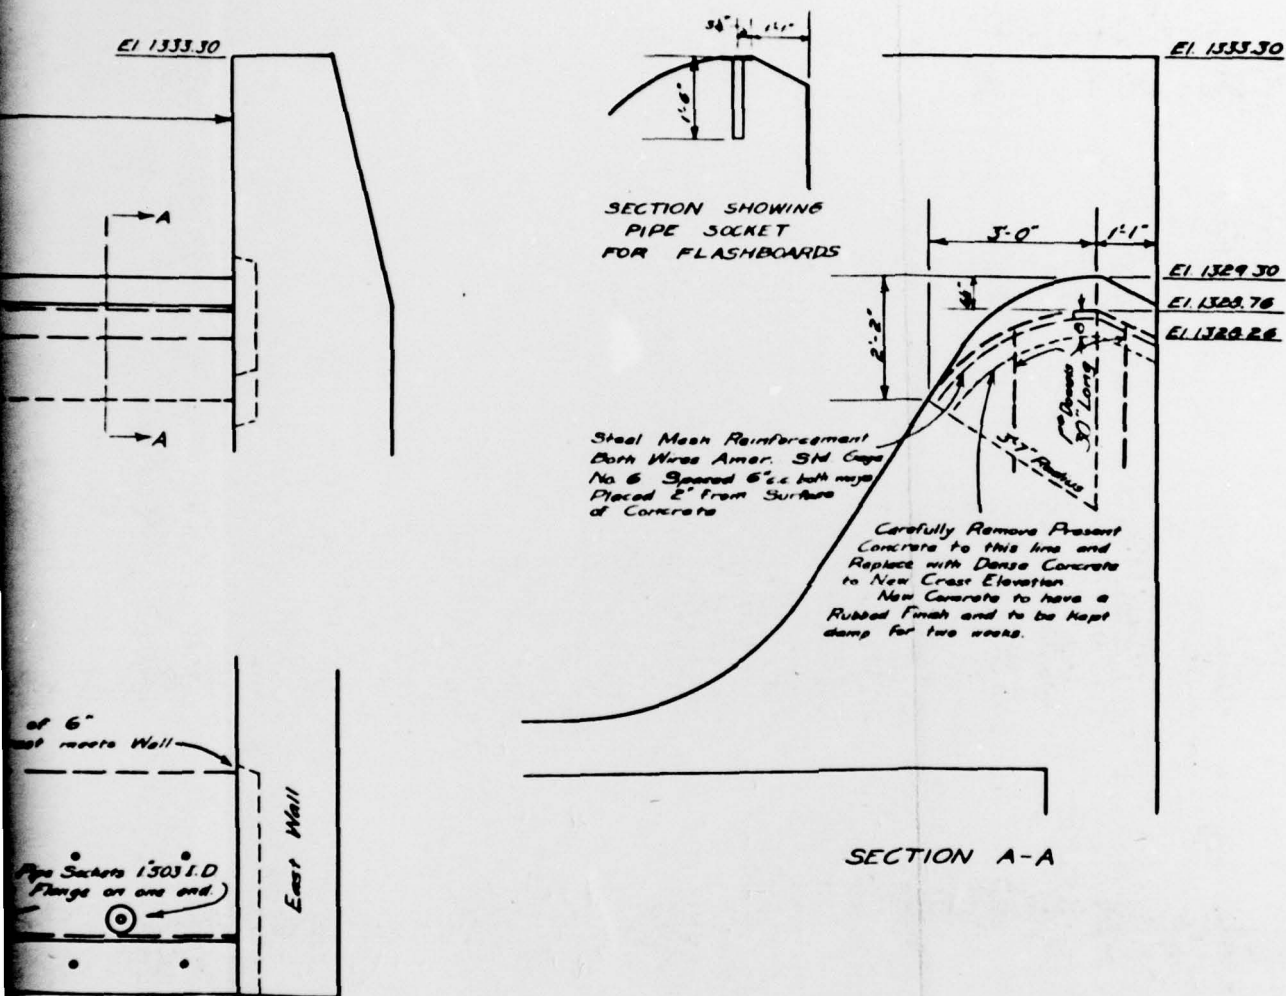
BLAIR GAP WATER SUPPLY CO.
POTTSGROVE DAM
PROPOSED LOWERING OF
SPILLWAY CREST

The new spillway channel was damaged by high water resulting from the flood of March 1936, which measured 1.7 feet below the top of dam or 2.3 feet above the spillway crest. The spillway crest was subsequently lowered by about 7 inches to its present elevation (see Figure 5). Also in 1936, a small grouting program was implemented at the left abutment that successfully stopped seepage in that area.
